Sample Home Inspection Report

Feel Safe Home Inspection LLC

Needs Repair Summary

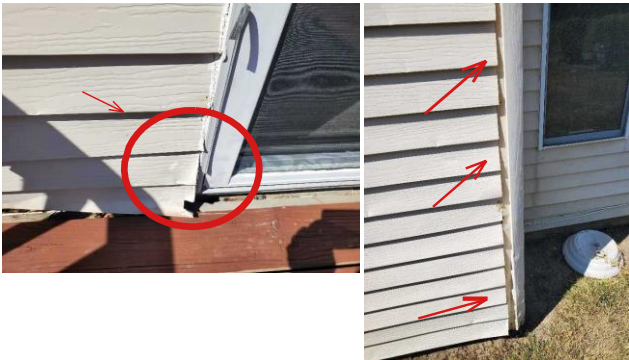
2. Entire townhouse Exterior Surface Type: Aluminum siding - Siding next to patio door is pulled away water can get behind. Corner of fireplace siding needs repair it is pulled away and can cause water to enter house

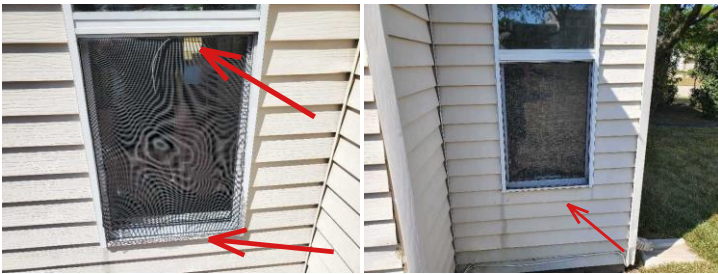
4. Window Screens: Screen is torn and will need repair

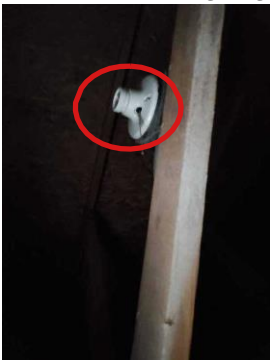
5. Main Attic Wiring/Lighting: No bulb in fixture

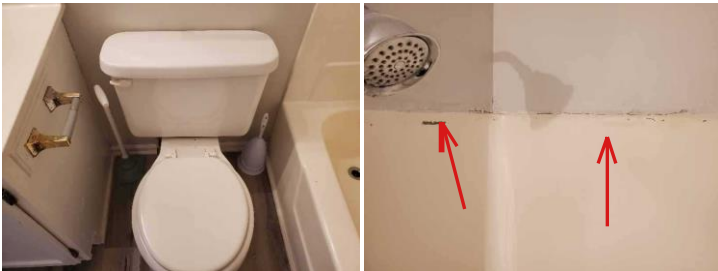
6. 2nd floor main Bathroom Toilets: Water continues to run after flushing very long time to fill fully

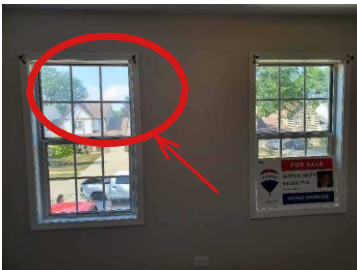
7. Master Bedroom Windows: Aluminum double hung - Window has fogging between the layers of glass

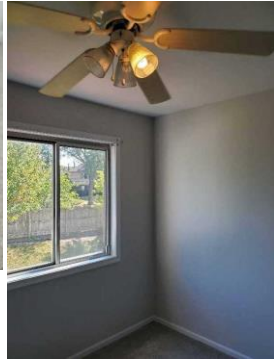
8. Behind bathroom Bedroom Electrical: 110 VAC outlets and lighting circuits - **Open or missing ground most outlets light bulb burned out**

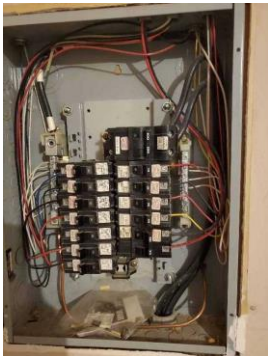
10. Garage Electric Panel Manufacturer: Federal Pacific - **Federal Pacific panel breakers have a history of not tripping when circuit overloading exists**

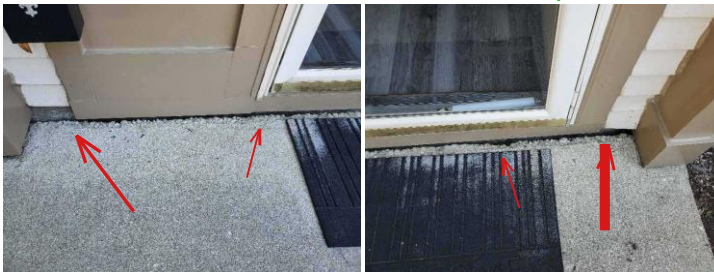
4. Acceptable Porch: Concrete - Watch to make sure the porch doesn't further separate from house

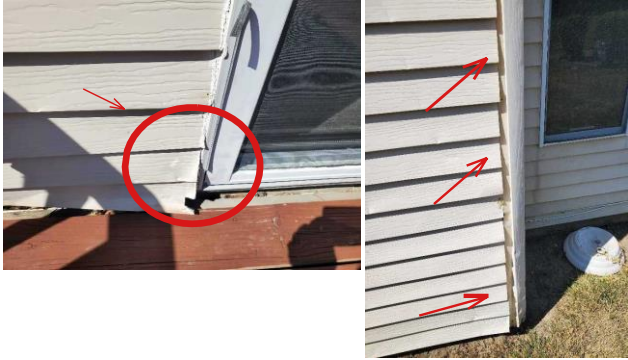
1. Needs Repair Type: Aluminum siding - Siding next to patio door is pulled away water can get behind. Corner of fireplace siding needs repair it is pulled away and can cause water to enter house

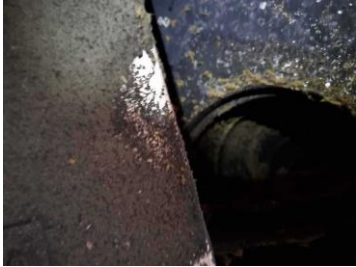
1. Acceptable Freestanding Stove: Wood burning - Recommend cleaning and inspection prior to use
2. Acceptable Fireplace Construction: Prefab
3. Type: Gas log
4. Acceptable Fireplace Insert: Standard
5. Acceptable Smoke Chamber: Metal
6. Acceptable Flue: Metal

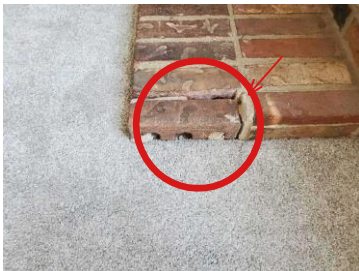
7. Acceptable Damper: Metal
8. Acceptable Hearth: Flush mounted - Loose brick

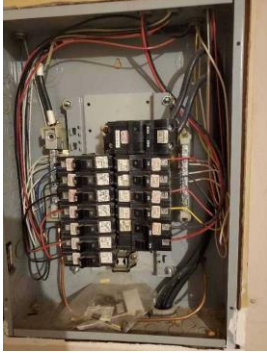
Garage Electric Panel

7. Needs Repair Manufacturer: Federal Pacific - Federal Pacific panel breakers have a history of not tripping when circuit overloading exists
